Manhole Inspection Summary

Manhole # S13A__026MH

Insp Date: **12/3/07 2:55 PM**

Location Address: **REAR OF 2876 LANVALE ST** Cross Street: **POPLAR GROVE ST**

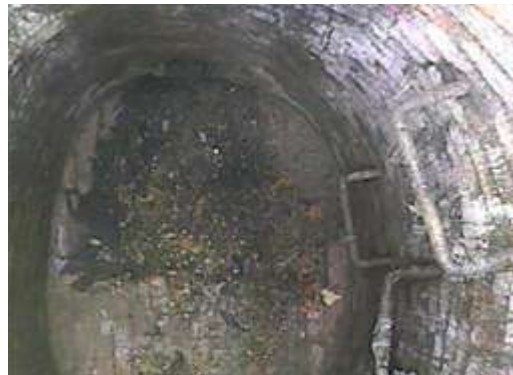
Defect 1

Steps Count: **4** Missing: **0** ☒ **Corroded**

CORRODED STEPS

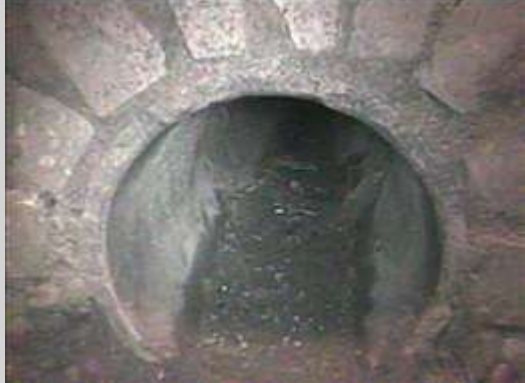
12 O'Clock Outflow

8 in. Circular Gravity Sewer
Pipe Out @ 12 O'Clock

Pipe Material: **Clay** ☐ Pipe Lined

Invert Depth: **6.85** (ft.) Flow Characteristics: **None**

Deposits: ☒ None ☐ Mud ☐ Sludge ☐ Debris ☐ Grease

Infiltration: **None** Pipe Seal Cond: **Sound**
